CSB Envelope Enhancement

darntonegs

Existing Photos

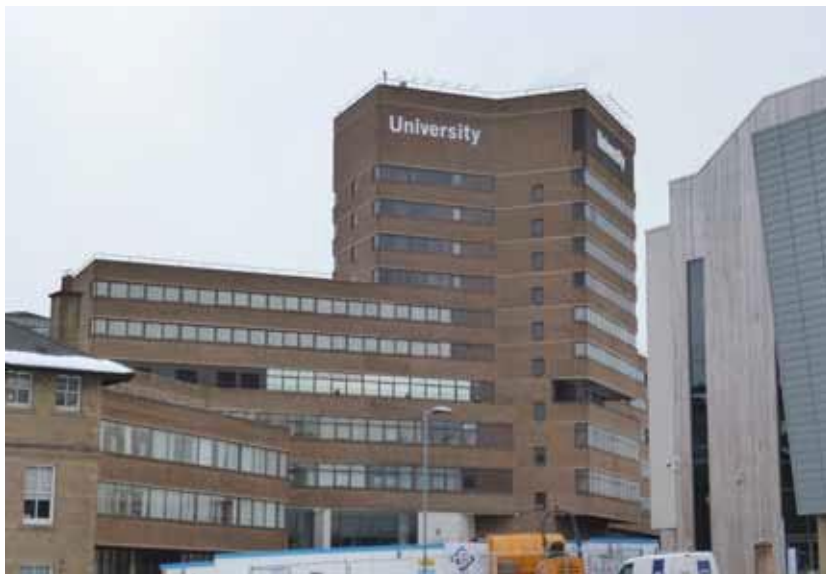
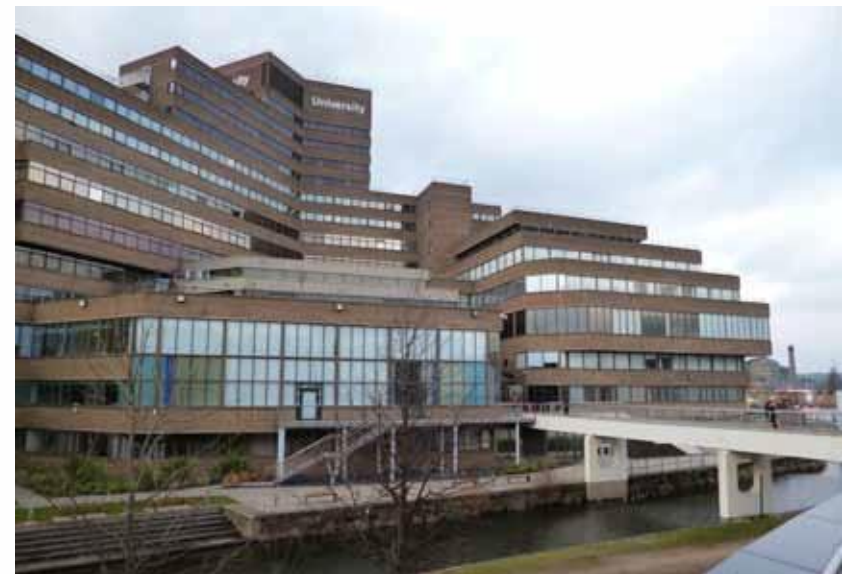
- Existing Envelope to be refurbished to refresh the look of the building and its performance
- Materials to have a minimum lifespan of 25 years.
- The existing single glazed windows are now 40 years old and are in urgent need of replacement

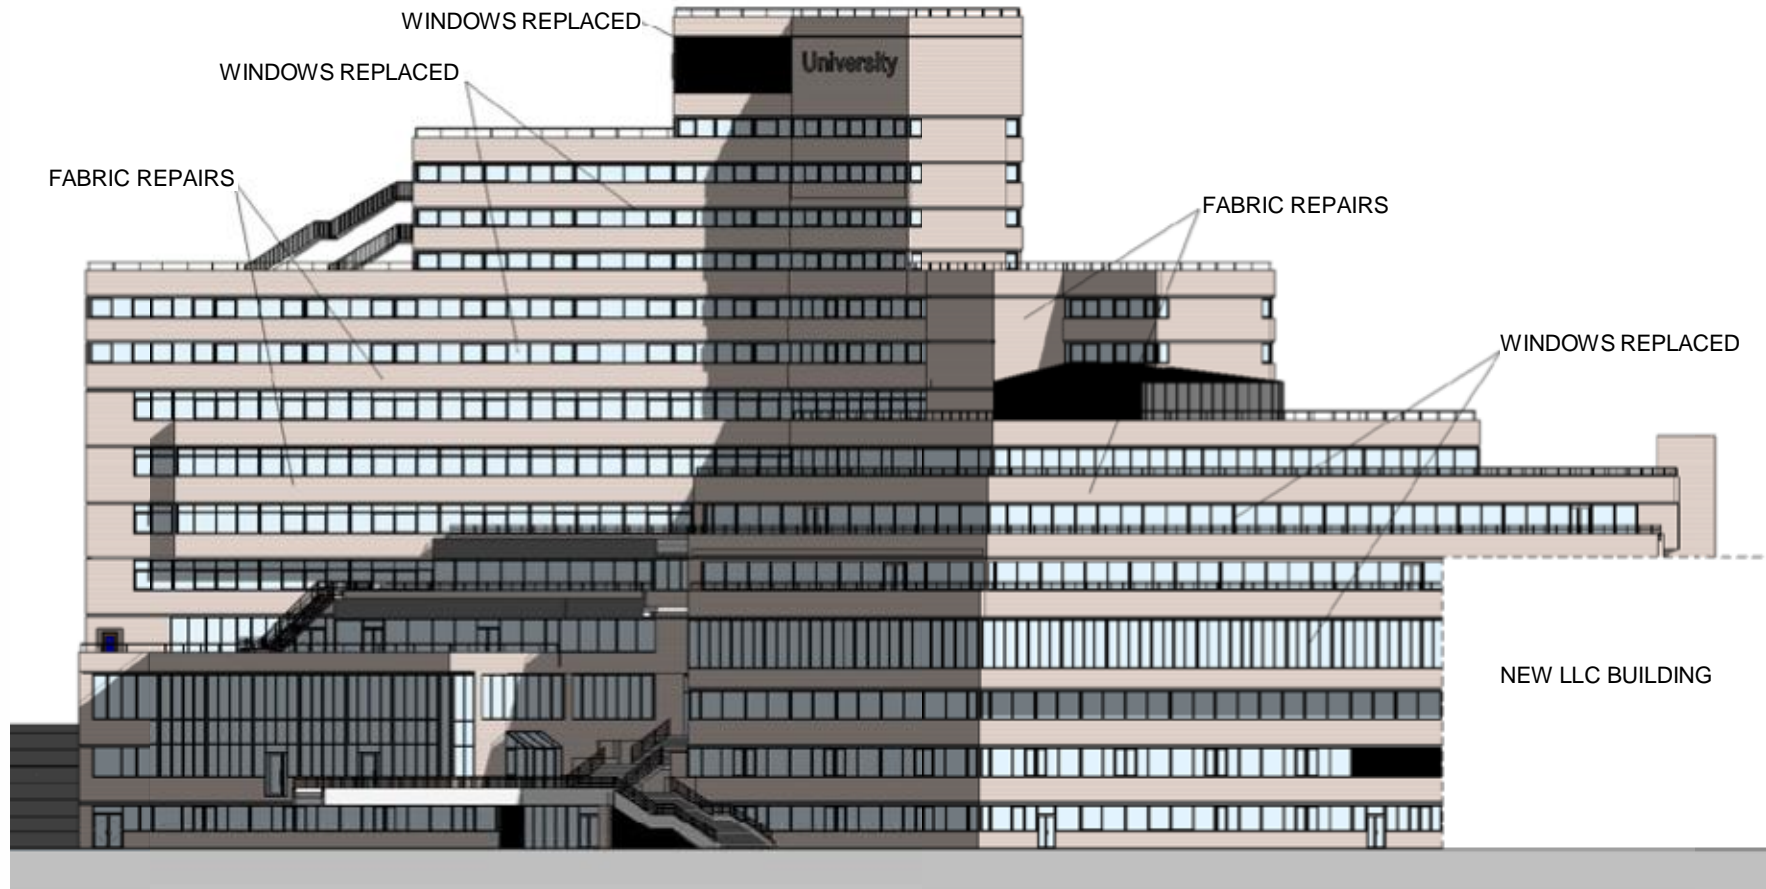
East

- Windows, doors & louvre replacement
 - This totals 687No bays of windows with an over all length of 2177 linear meters.
- Fabric improvement including cavity insulation and wall tie replacement
 - Cavity insulation will be installed to all areas (5500m²) with re pointing and wall tie replacement to approx 25% of the envelope (1500m²).
- Concrete repairs as required
- Brick work repairs as required
- Key drivers from the University are to minimise end user disruption and to ensure that phase 1 is completed for 10th January 2014 when the LLC project is handed over

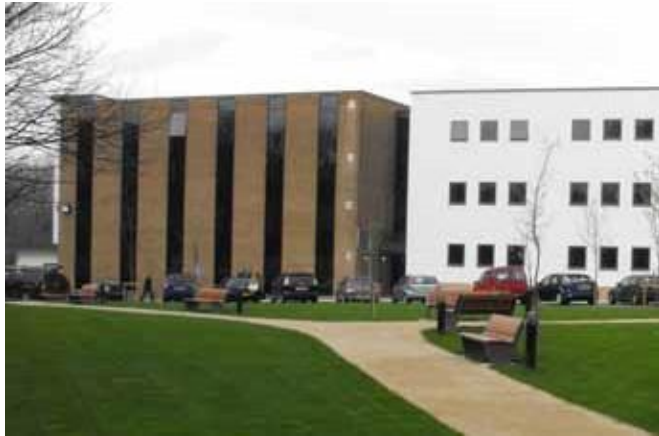
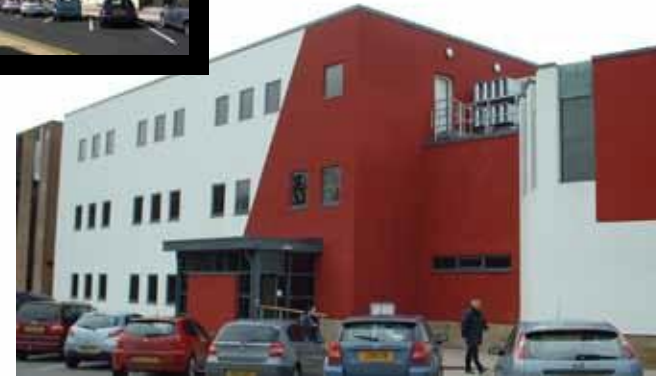
Music Building

Before

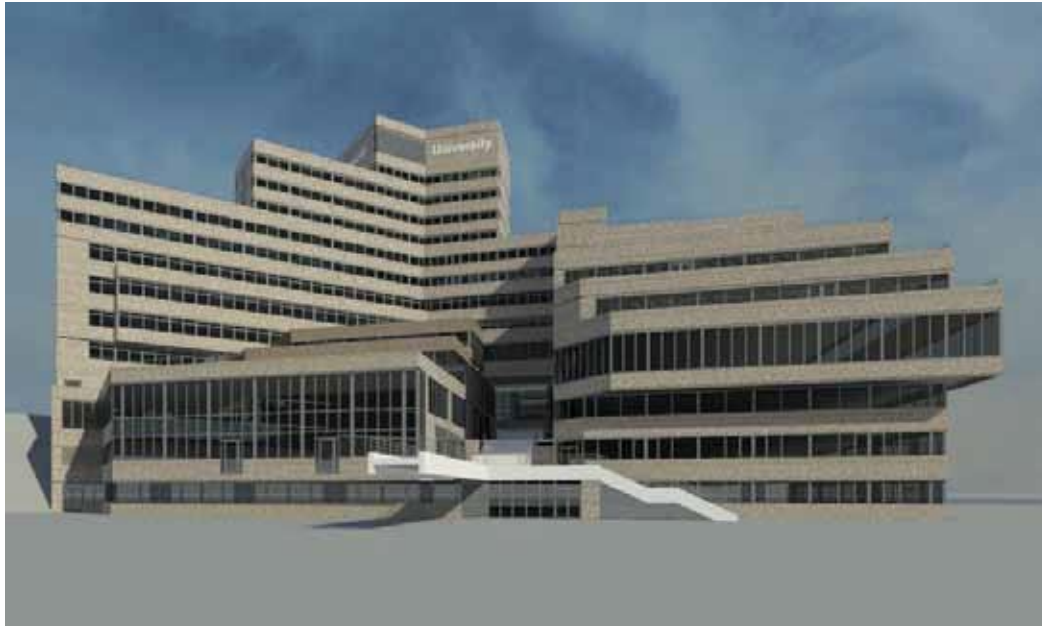
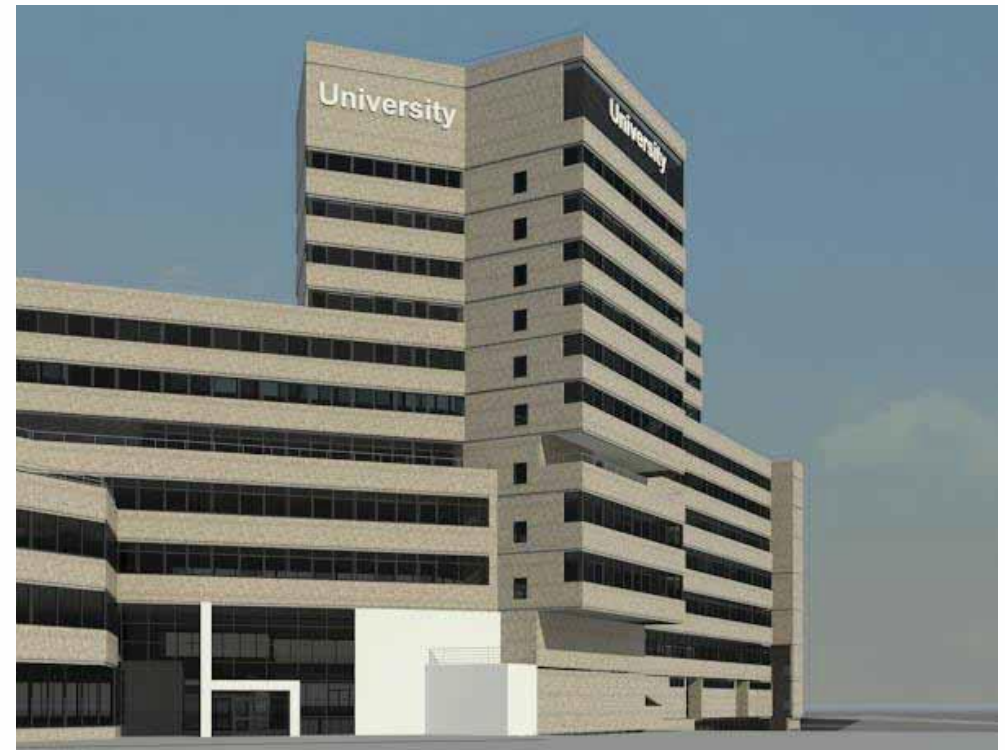
- Masonry cavities to be filled with knauf supafil 40 mineral wool cavity insulation.
- Where required wall ties are to be replaced with stainless steel
- Where required facing brickwork to be re pointed
- Existing brickwork to be cleaned
- Concrete repairs to be undertaken where required
- Brick cills to be replaced where required
- Brick work to parapet walls to be repaired where defective.

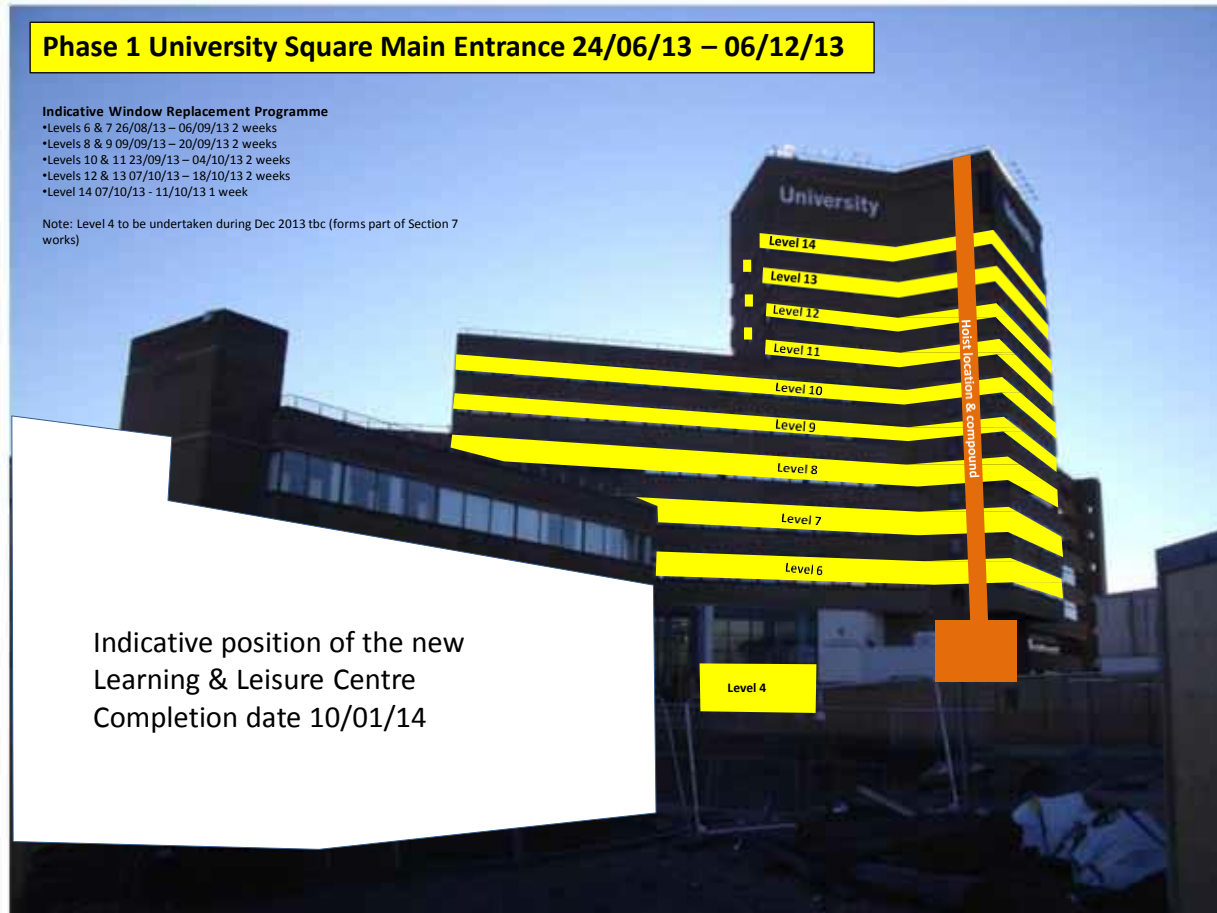
Phase 1 University Square Main Entrance 24/06/13 – 06/12/13

- Levels 6 & 7 26/08/13 – 06/09/13 2 weeks
- Levels 8 & 9 09/09/13 – 20/09/13 2 weeks
- Levels 10 & 11 23/09/13 – 04/10/13 2 weeks
- Levels 12 & 13 07/10/13 – 18/10/13 2 weeks
- Level 14 07/10/13 - 11/10/13 1 week

Note: Level 4 to be undertaken during Dec 2013 tbc (forms part of Section 7 works)

Indicative position of the new
Learning & Leisure Centre
Completion date 10/01/14

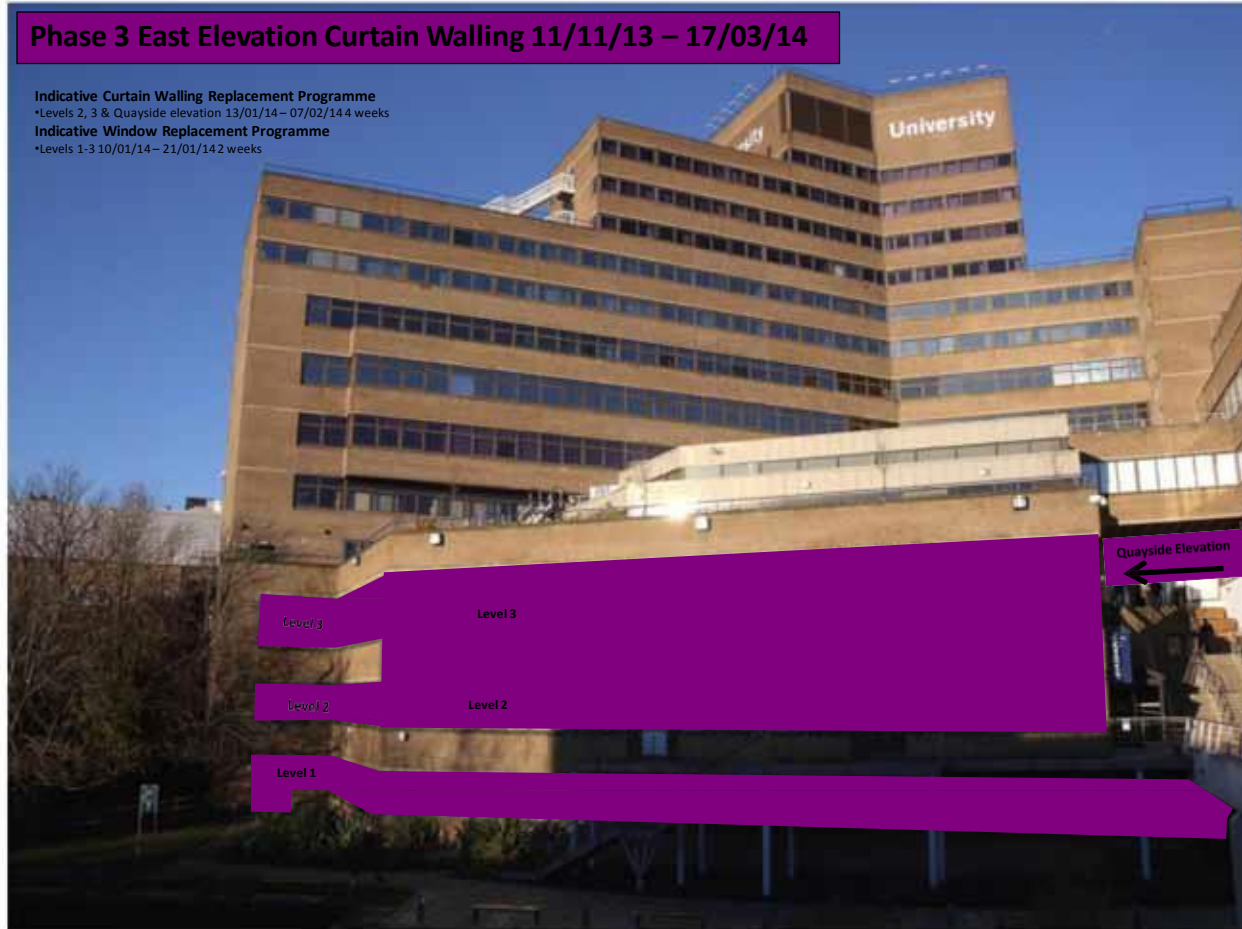
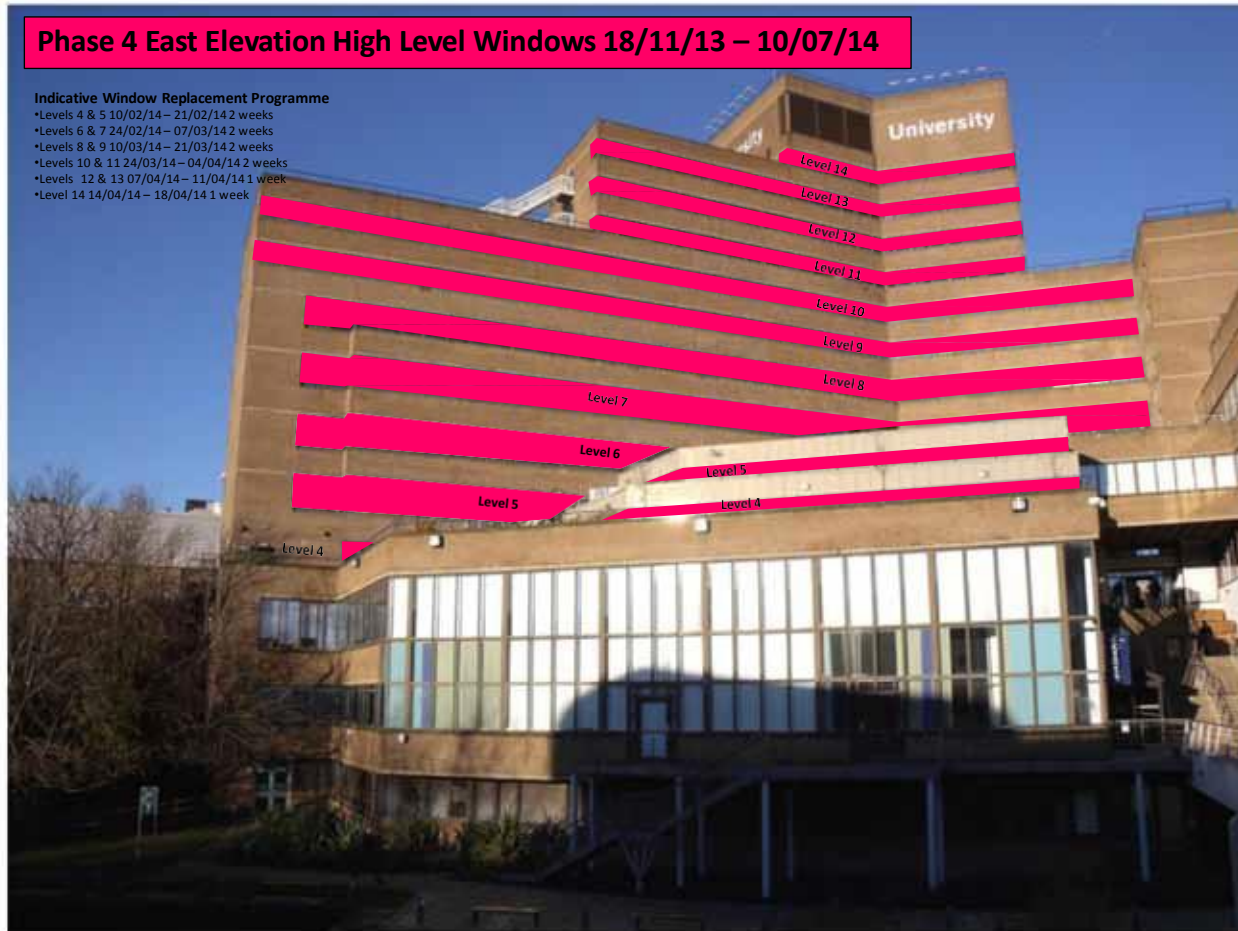
Phase 3 East Elevation Curtain Walling 11/11/13 – 17/03/14

Indicative Curtain Walling Replacement Programme
*Levels 2, 3 & Quayside elevation 13/01/14 – 07/02/14 4 weeks
Indicative Window Replacement Programme
*Levels 1-3 10/01/14 – 21/01/14 2 weeks

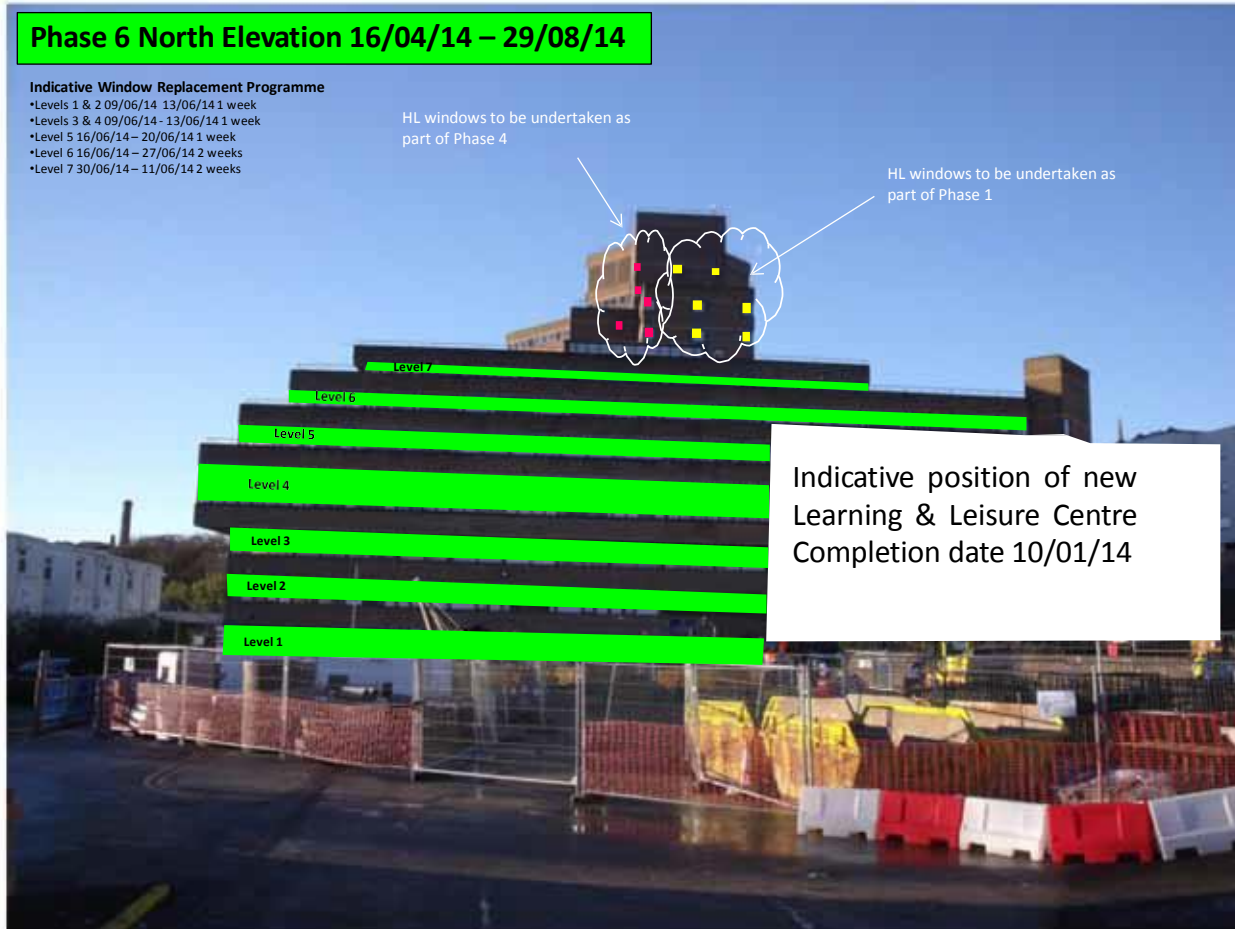
Phase 6 North Elevation 16/04/14 – 29/08/14

- Levels 1 & 2 09/06/14 - 13/06/14 1 week
- Levels 3 & 4 09/06/14 - 13/06/14 1 week
- Level 5 16/06/14 - 20/06/14 1 week
- Level 6 16/06/14 - 27/06/14 2 weeks
- Level 7 30/06/14 - 11/07/14 2 weeks

HL windows to be undertaken as part of Phase 4

HL windows to be undertaken as part of Phase 1

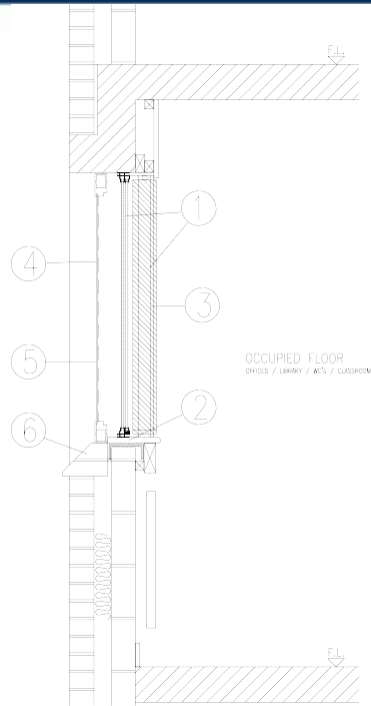
Part 1

1. Strip blinds & secondary glazing
2. Rip down cill board
3. Temporary screen (to minimise noise & dust)
4. Deglaze Unit
5. Remove window
6. Repair external cill (If required)
